**TRANSPORTATION SCIENCES  
CRASH DATA RESEARCH CENTER**

Veridian Engineering  
Calspan Operations  
Buffalo, New York 14225

**CALSPAN ON-SITE AIR BAG RELATED CHILD FATALITY INVESTIGATION  
CALSPAN CASE NO. CA96-010  
VEHICLE - 1996 DODGE CARAVAN SE  
LOCATION - TENNESSEE  
CRASH DATE - 1996**

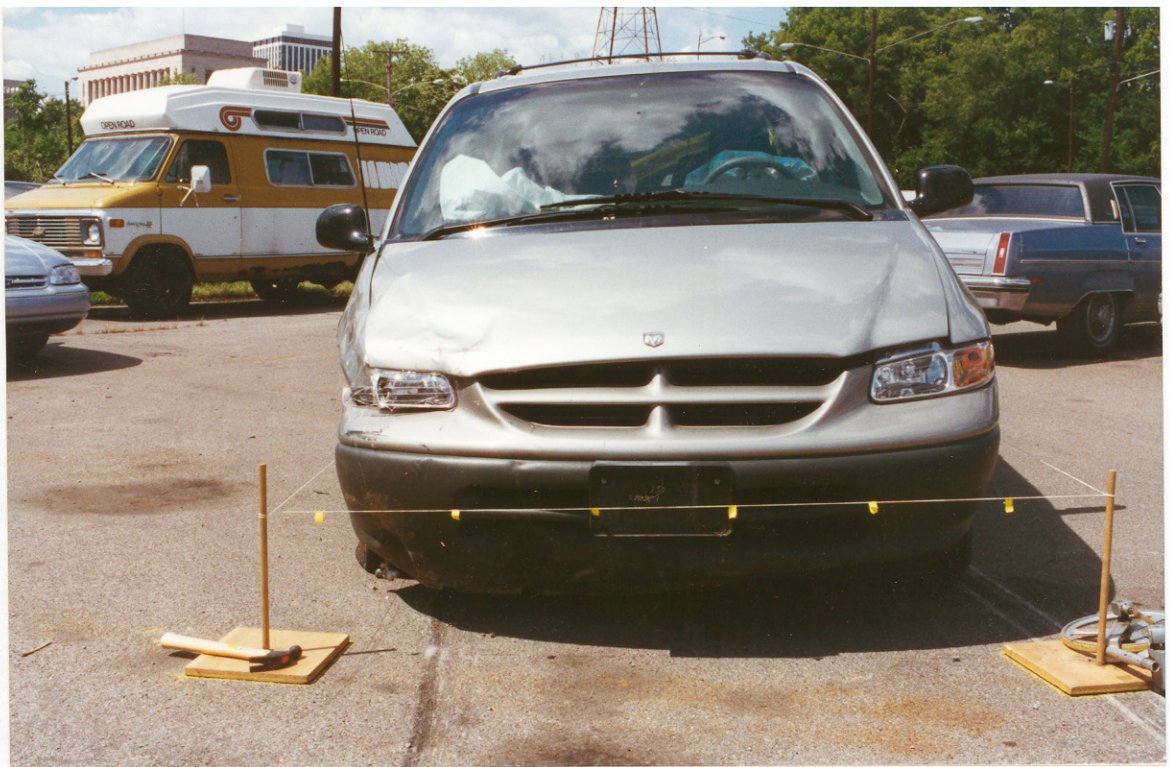
28. Frontal damage to the Dodge Caravan.

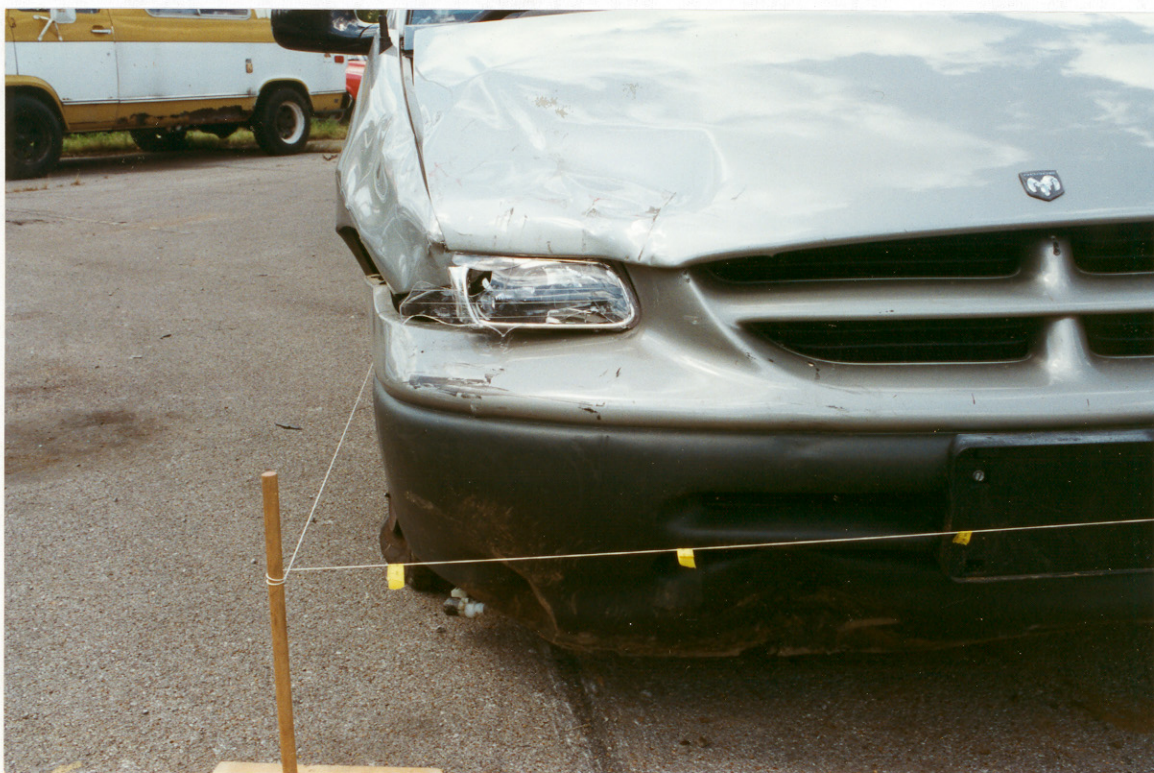
30. View of the direct contact damage to the Dodge Caravan.

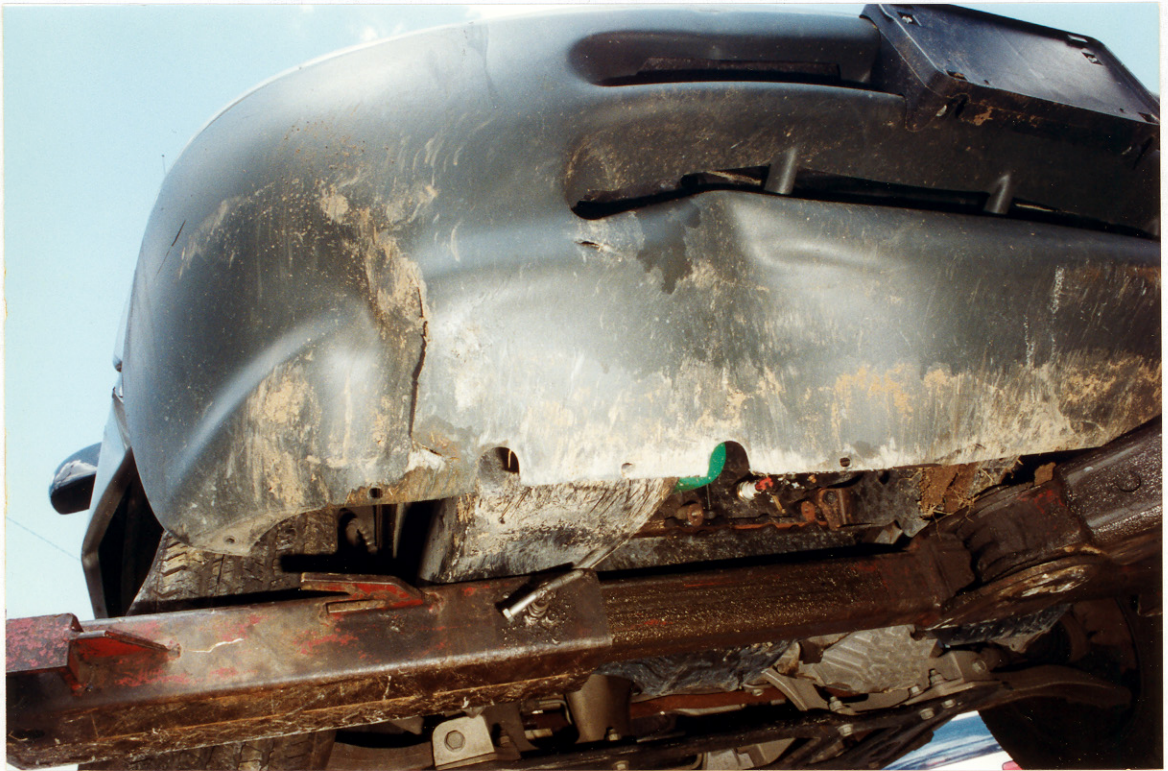
36. Close up view of damage to the lower surface of the bumper fascia.

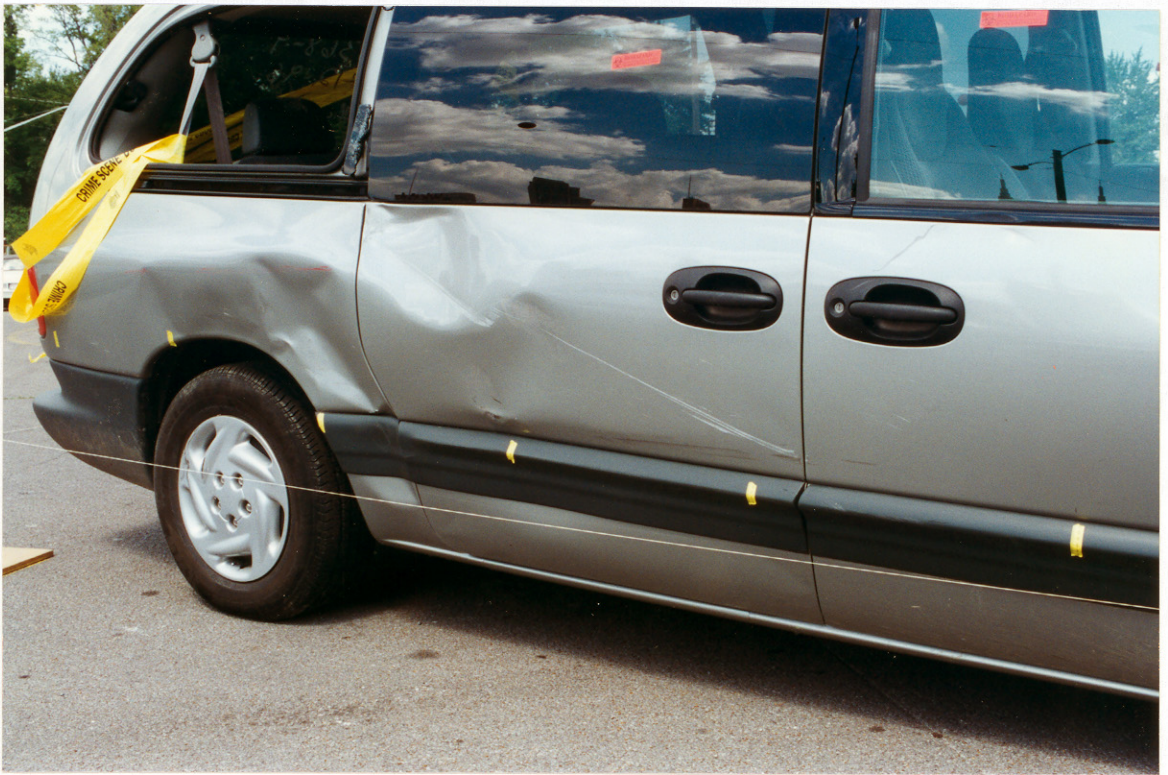
44. Right rear side slap damage to the Dodge Caravan.

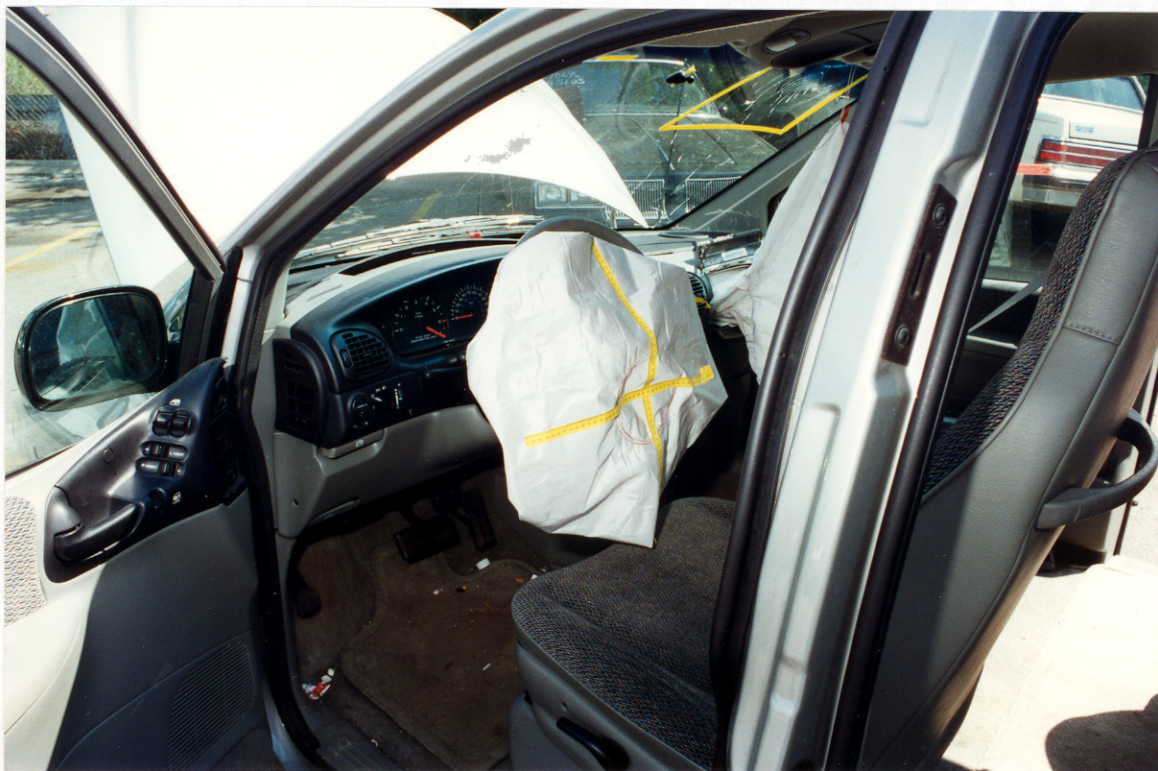
49. Angular view of the driver's compartment.

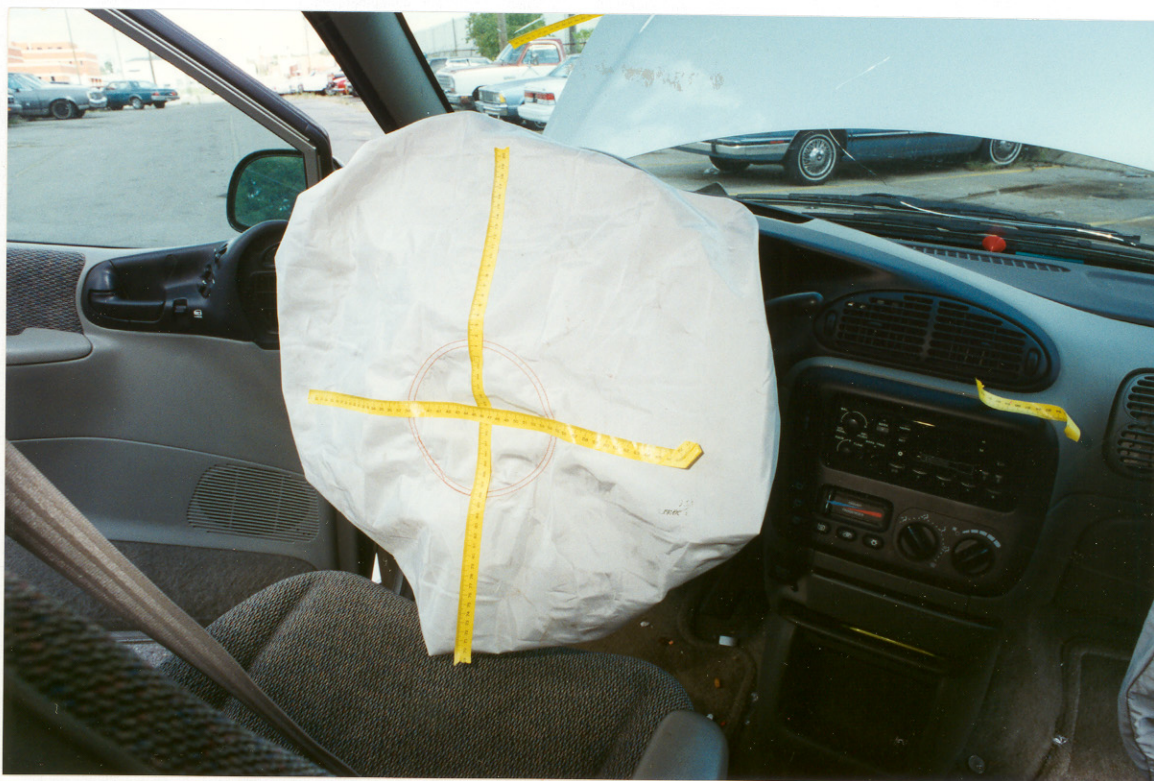
52. Overall view of the deployed driver side air bag.

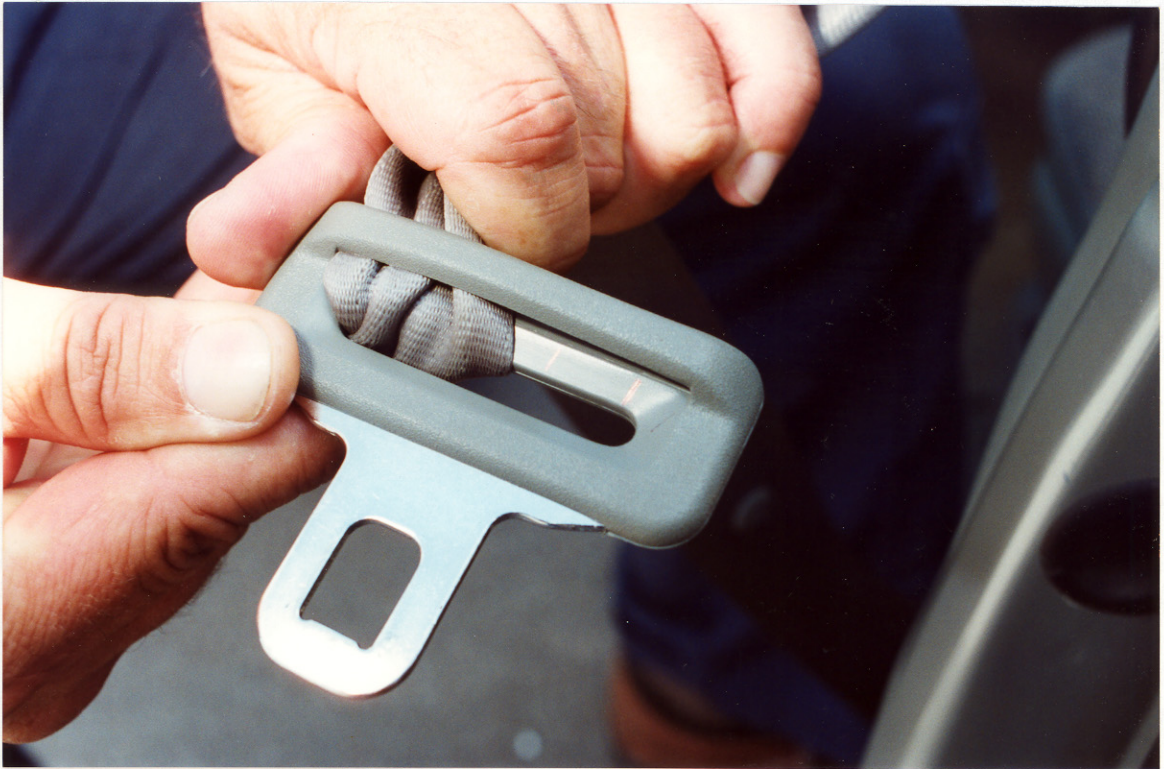
The 1996 Dodge Caravan was equipped with manual 3-point lap and shoulder belts in the six outboard seated positions. The front seat belt systems consisted of a continuous loop lap and shoulder belt webbings with locking latchplates. Emergency locking retractors were mounted in the base of each B-pillar. The belt systems utilized an adjustable upper anchorage (D-ring). The driver's D-ring was found adjusted to a point that was 2.0 cm (0.8 in) below the full up position, or 7.6 cm (3.0 in) above the bottom adjustment point, yielding a total of 9.6 cm (3.8 in) of vertical adjustment. The driver was wearing the manual 3-point shoulder belt. Routine usage marks present on the latchplate. There was no loading evidence on the driver's seat belt webbing, however, the latchplate crossbar exhibited a 1.3 cm (0.5 in) abrasion to the polymer coating at the forward aspect of the crossbar (refer to Photograph No. 59).

59. View of an abraded area on the plastic covering the latch plate.

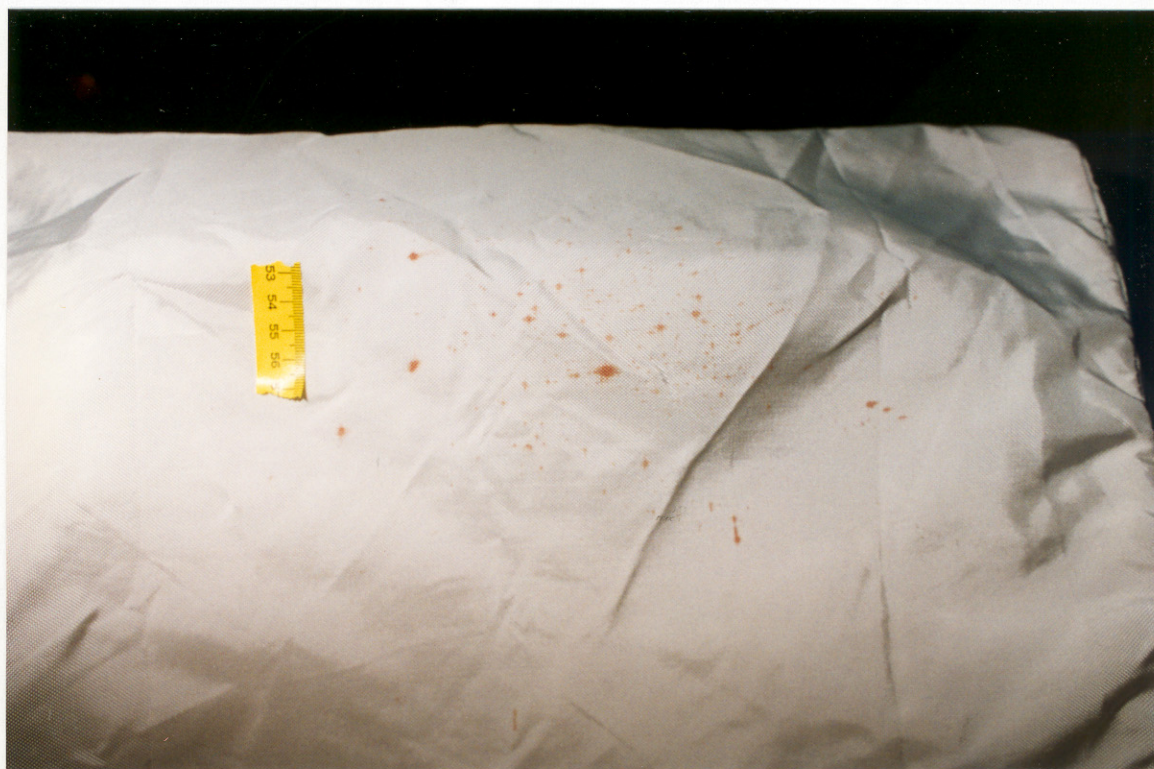
71. Close-up view of the blood spatters at the 12 o'clock position.

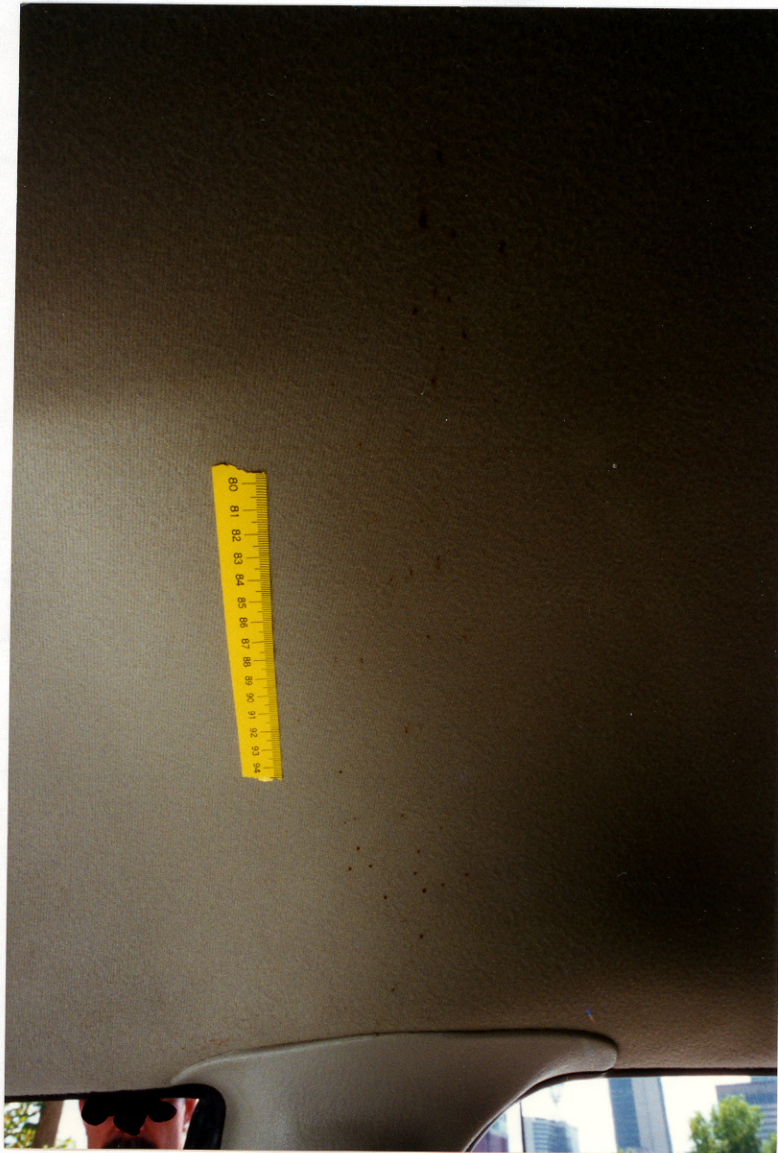
78. Close-up view of the blood spatters on the headliner.

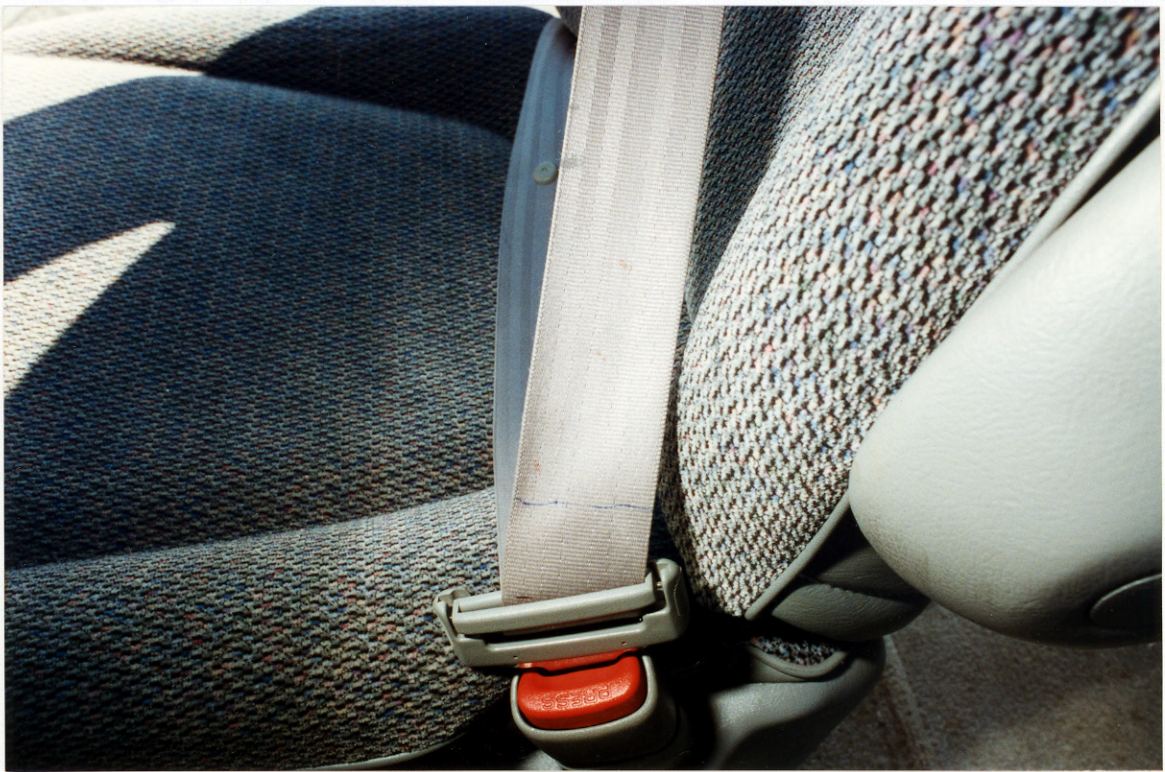
87. View of blood spatters on the right front restraint webbing.

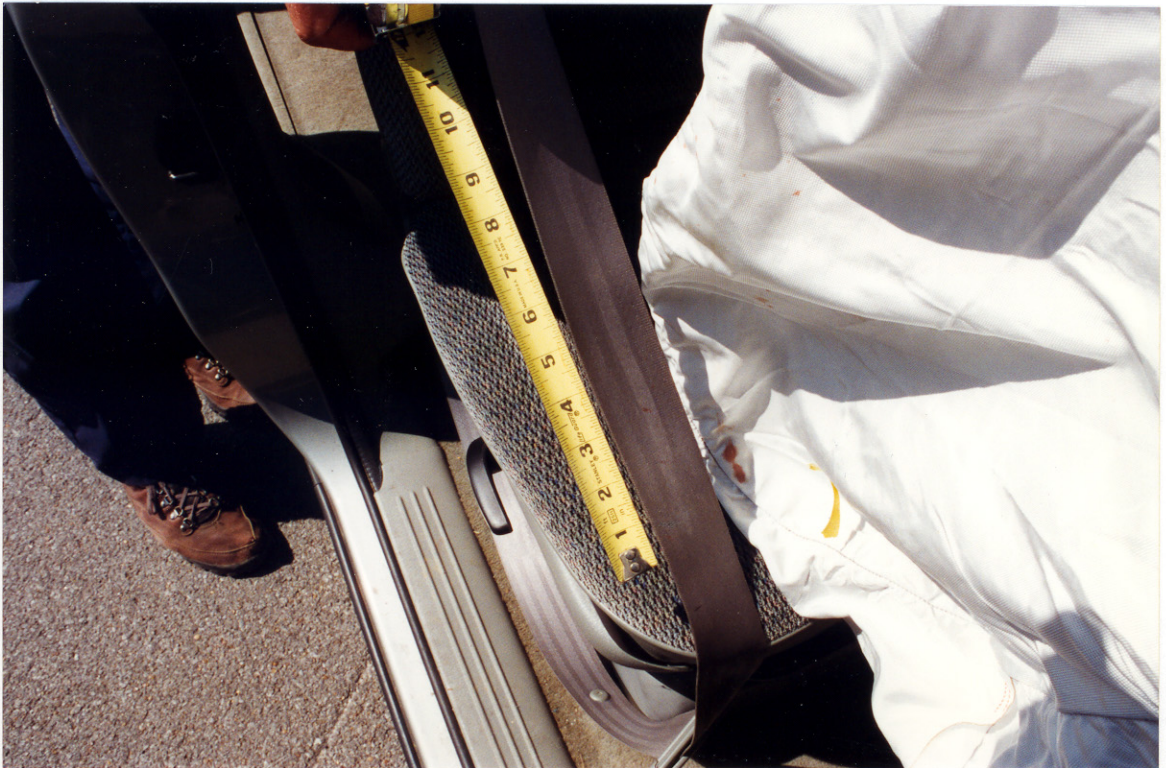
The 5 year old child passenger was seated in the right front position and was restrained by the lap portion of the restraint with the shoulder belt probably positioned behind her back. The right front D-ring was adjusted to the full down position (refer to Photograph No. 85). A faint abrasion was noted on the outboard aspect of the plastic crossbar of the latchplate (refer to Photograph No.88). There were blood stains noted 7.6-15.2 cm (3.0-6.0 in) outboard of the latchplate on the lap portion of the webbing. There were also eight (8) small blood stains noted on the shoulder aspect of the belt webbing (refer to Photograph N. 87). The stains were located 5.1-15.2 cm (2.0-6.0 in) above the latchplate. These stains probably were deposited after the child rebounded back under the shoulder belt webbing in the later stages of the crash sequence. A fluid spill was also noted on the right front restraint webbing (refer to Photograph Nos. 89-92), however, this did not appear to be related to the crash.

90. View of a fluid spill on the right front restraint webbing.

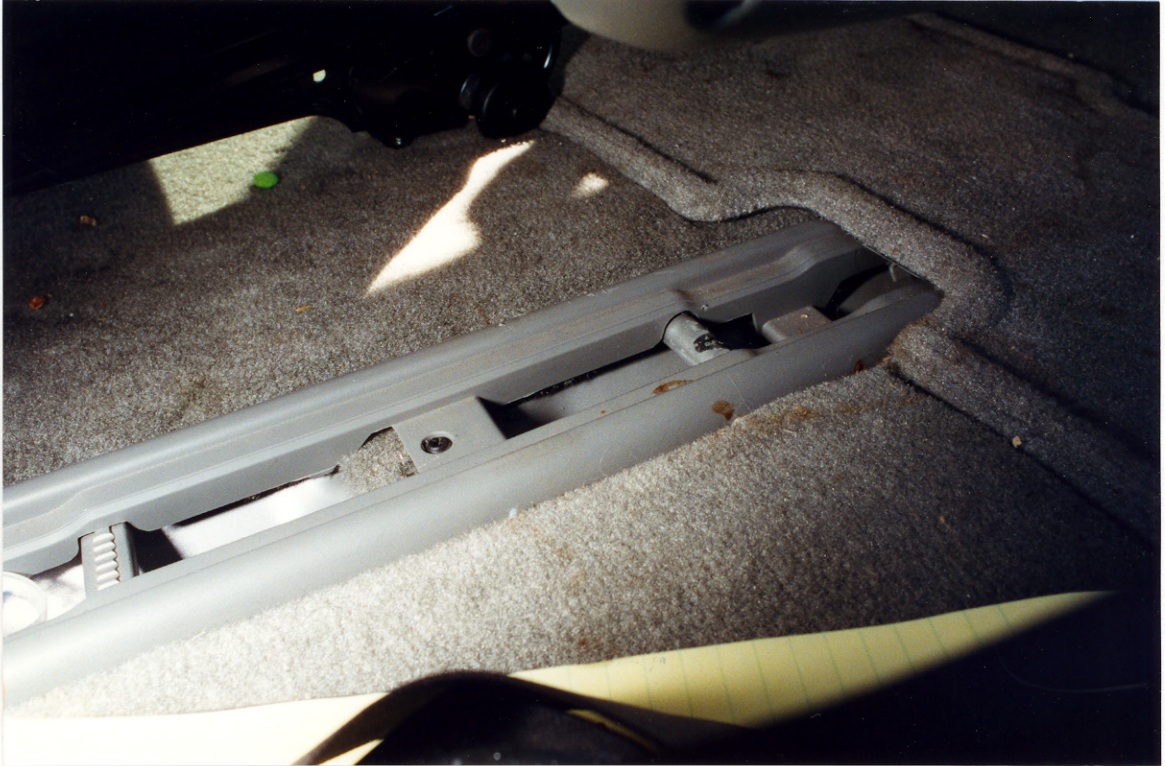
child safety seat on the seat cushion. Abrasions were noted to the shoulder belt webbing and to the plastic extrusion at the seat cushion/seat back juncture. In addition, the loading produced a D-ring transfer to the shoulder belt webbing. This evidence is documented in Photograph Nos. 97-102.

98. View of the second seat's left side floor mount.

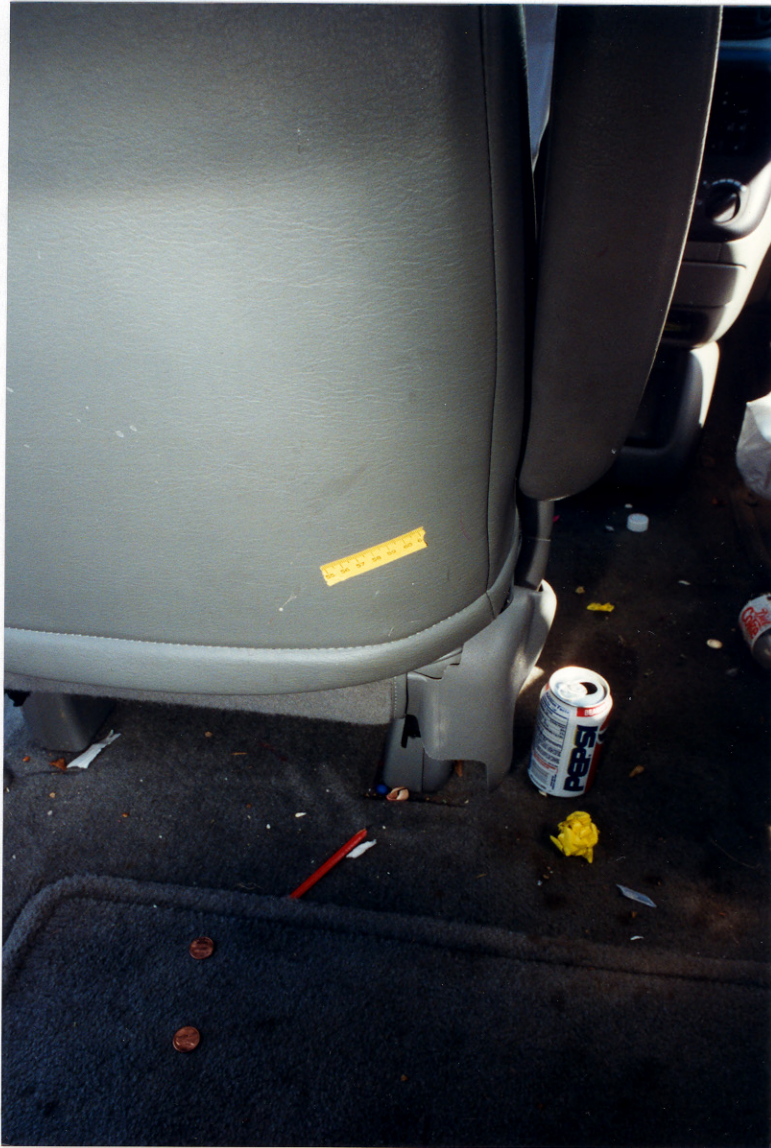
99. View of a contact to the left front seat back.

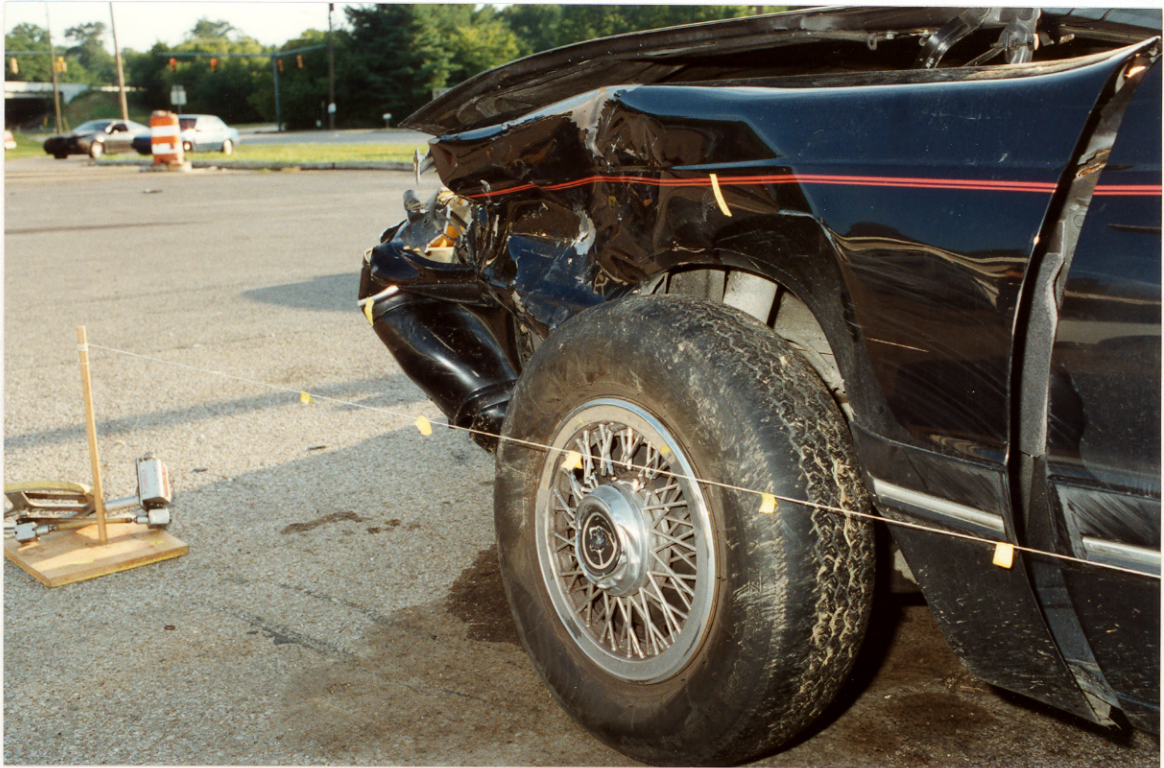
110. Left side view of the Mercury.
